Analysis of Spring Damage in the Chamber Actuator

Raven Rullyapatra Nasution^{1*}, Rudi Saputra²

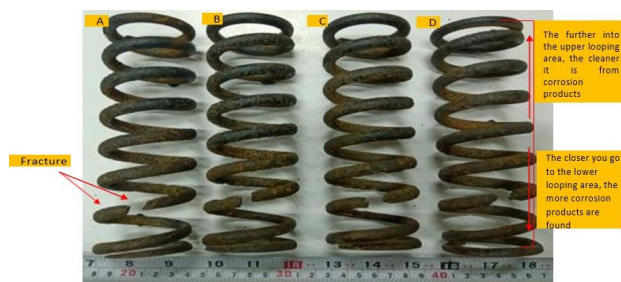
Figure 1. Visual material identification carried out on broken springs

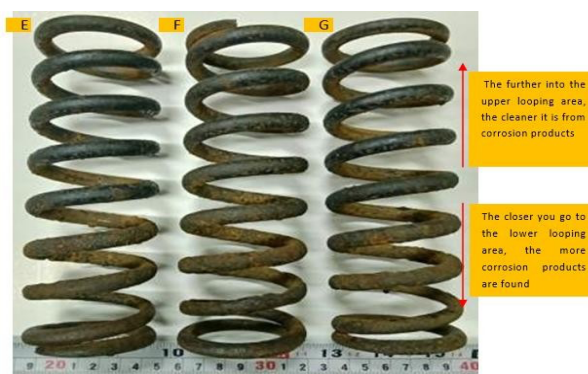
Figure 2. Visual material identification carried out on springs that are not broken

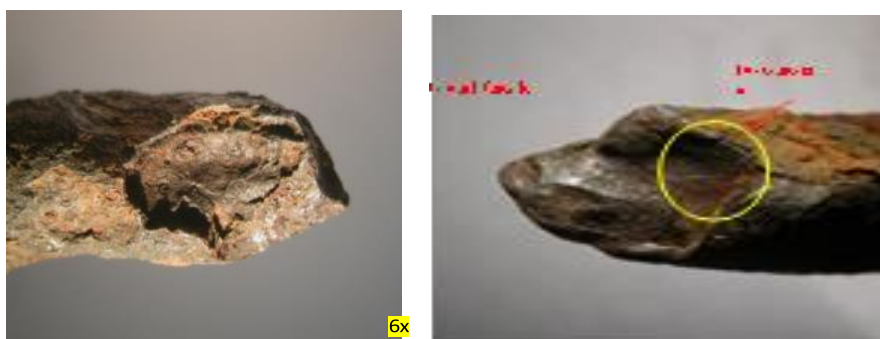
Figure 3. Fracture surface of spring sample A which experienced ductile fracture

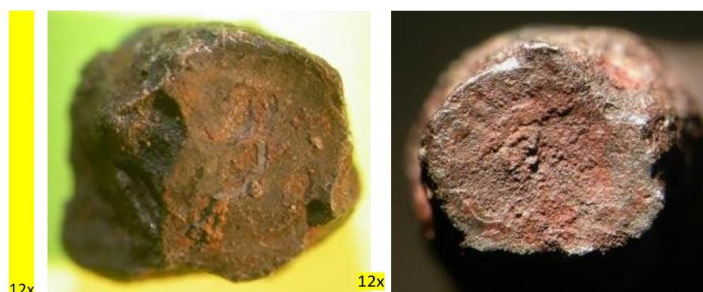
Figure 4. Fracture surface of broken spring sample B which experienced a Brittel fracture

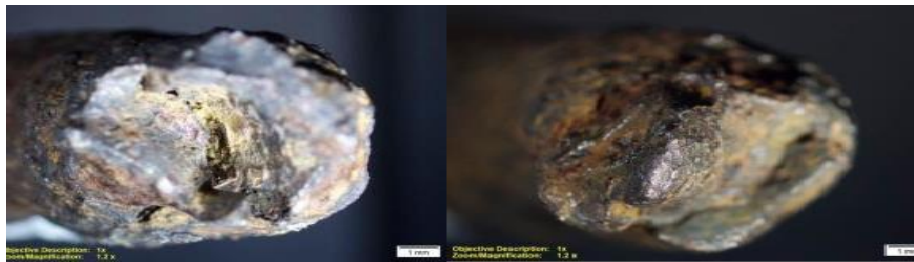
Figure 5. Fracture surface of broken spring sample C which experienced ductile fracture

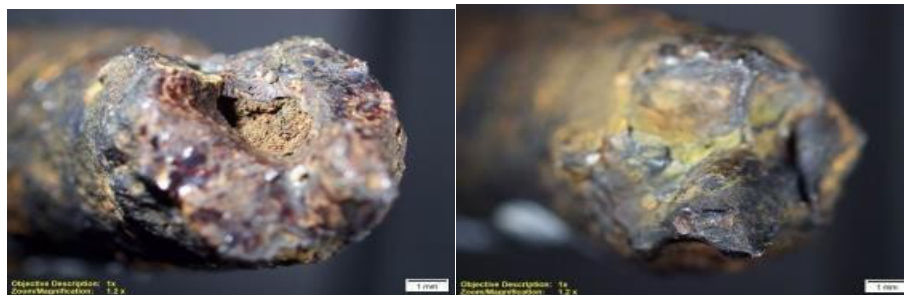
Figure 6. Fracture surface of a broken spring sample D which experienced ductile fracture.

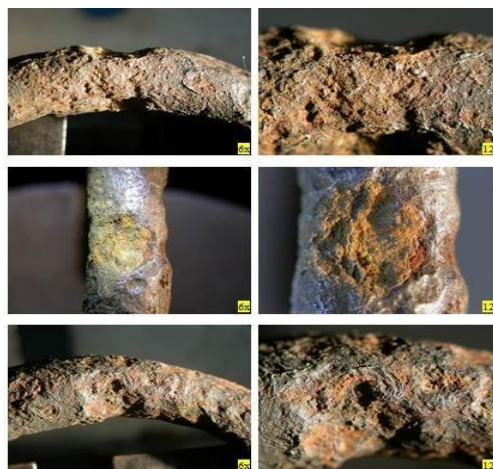
Figure 7. Thinning occurred and several forms of defects were found on the spring surface

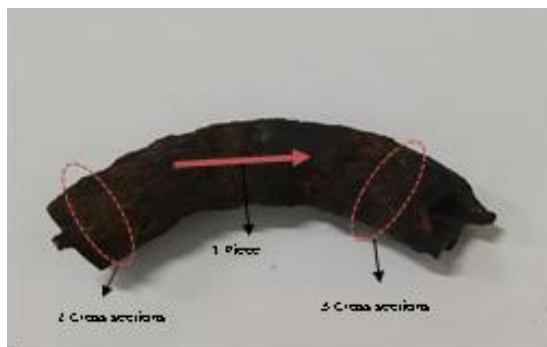
Figure 8. Location of Cutting Direction for Metallographic Sample Sample A

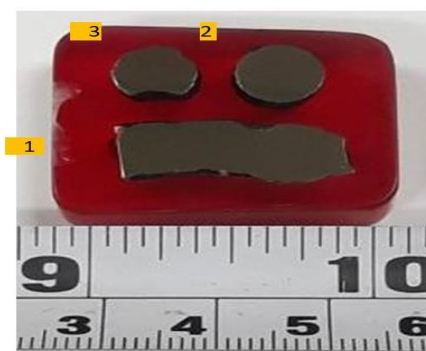
Figure 9. Location of Etched and Non-Etched Metallographic Examination of Spring Sample A

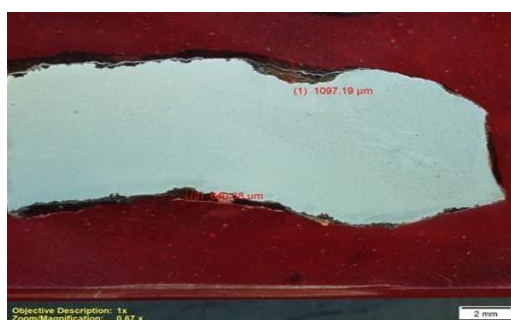
Figure 10. Macro photo of spring etching A fracture surface with a longitudinal cut

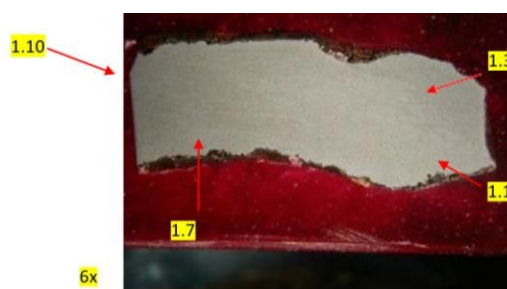
Figure 11 Photometallographic Location of Spring A, Fracture Surface with Longitudinal Sections.

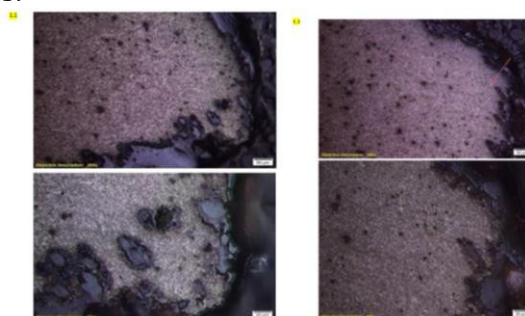
Figure 12. Metallographic examination of etching locations 1.1 and 1.3 with 200x and 500x magnification

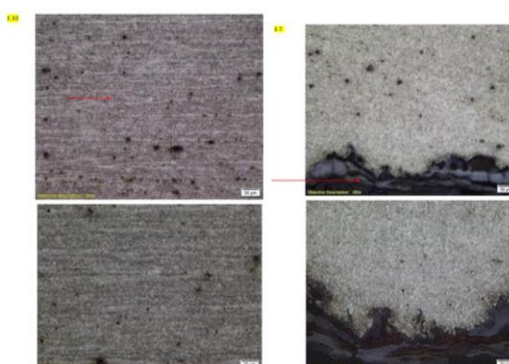
Figure 13. Metallographic examination of etching locations 1.10 and 1.7 with 200x and 500x magnification

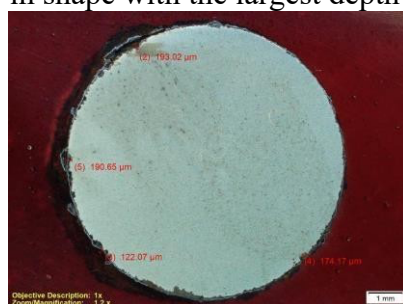
Figure 14 Full Macro Photo of Spring A Etching Location 2

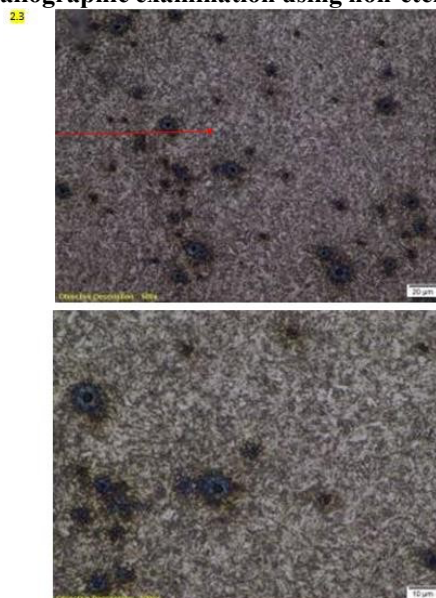
Figure 17 Metallographic examination of location etching 2.3 with 500x and 1000x magnification

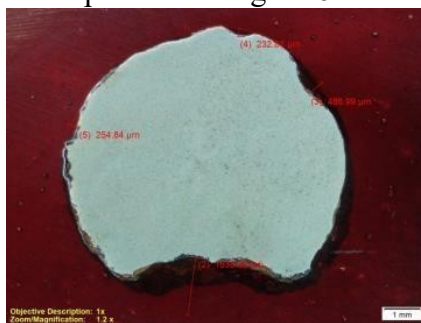
Figure 18 Macro Photo of Corroded Spring A Etching in Cross Section Location 3

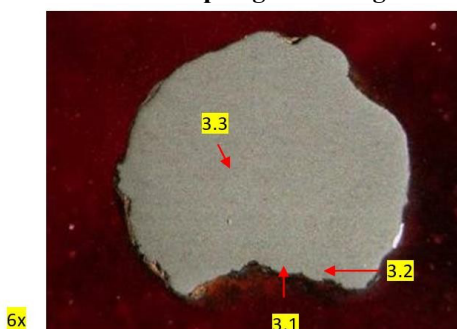
Figure 19 Metallographic Location of Corroded Spring A with Cross Section Location 3

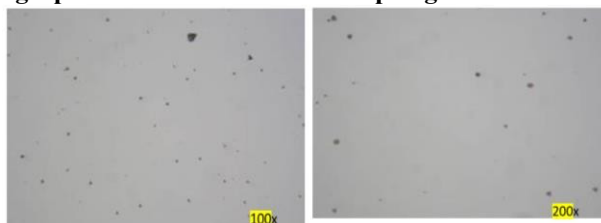
Figure 20 Non-Etching Metallographic Examination Location 3.3

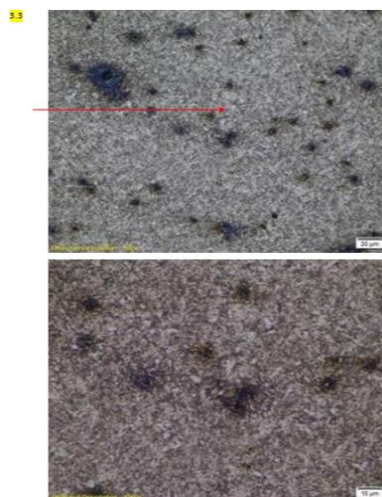
Figure 21 Metallographic examination of location etching 3.3 with 500x and 1000x magnification

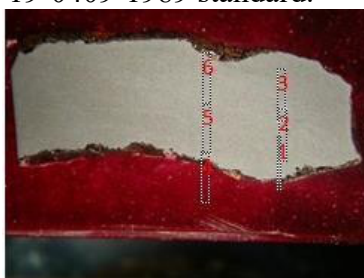
Figure 22 Location of Longitudinal Section Hardness Test for Broken Spring
Table 3 Longitudinal Cut Hardness Test Results Broken Spring

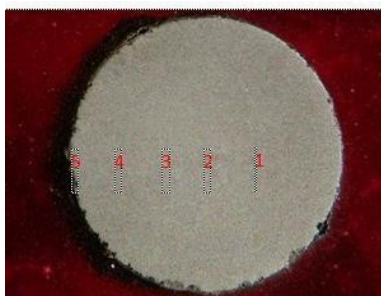
Figure 23 Location of Cross-Section Hardness Test of Whole Spring
Table 4 Cross Section Hardness Test Results Broken Spring

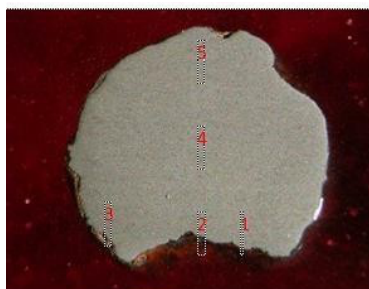
Figure 24 Location of Corroded Spring Cross Section Hardness Test
Table 5 Cross section hardness test results of corroded spring

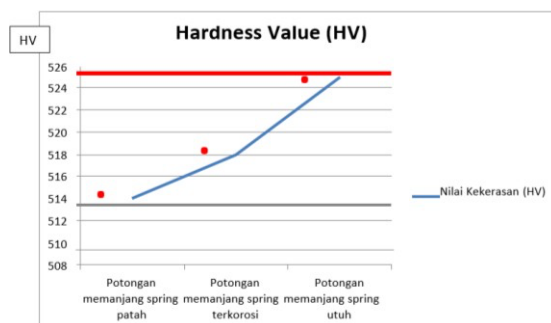
Figure 25 Graph of hardness value (HV) results

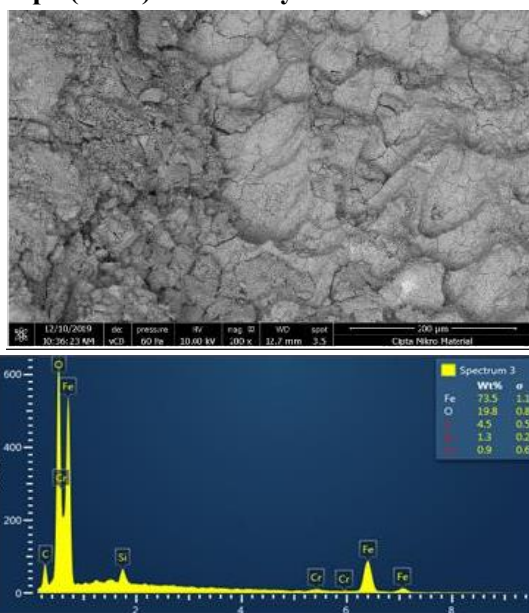
Table 6 SEM-EDAX Results of Fracture Surface *SpringA*

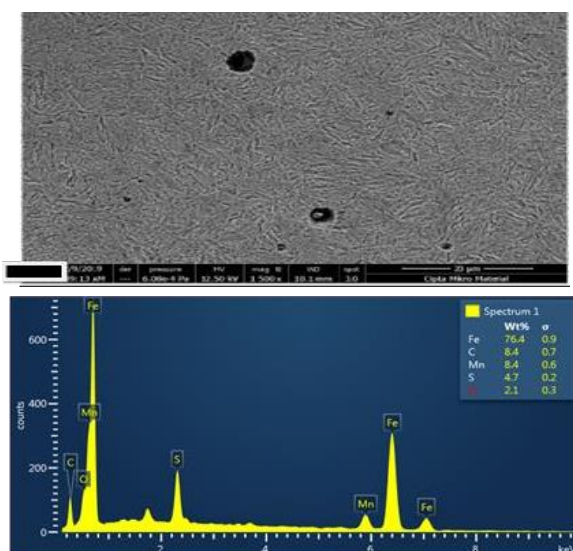
Table 7 SEM-EDAX Results of Fracture Surfaces of Spring A Metallographic Samples

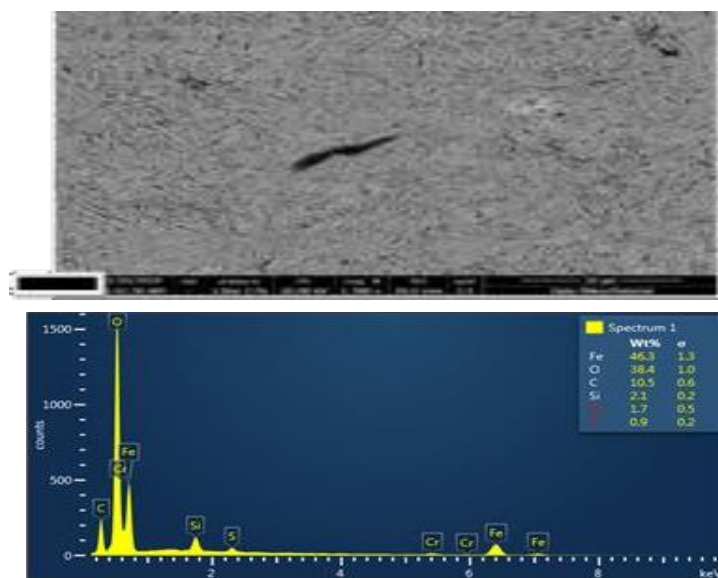
Table 8 SEM-EDAX Results of Hole Defects in Longitudinal Sections of Spring A
