Analysis of Spring Damage in the Chamber Actuator

Raven Rullyapatra Nasution¹, Rudi Saputra²

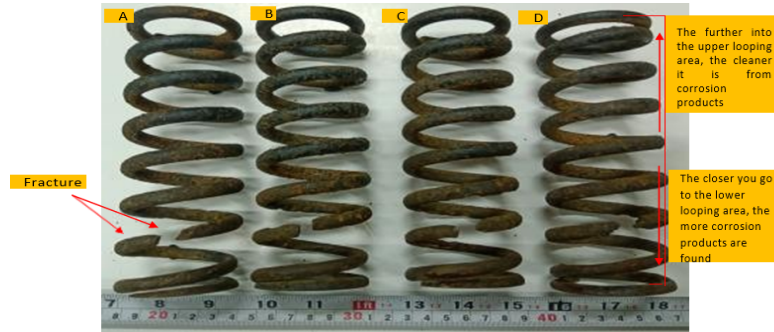
Figure 1. Visual material identification carried out on broken springs

From the results of visual observations of broken and unbroken springs, it can be seen that at the bottom of the spring the most corrosion production was found. Meanwhile, at the top, only a few corrosion products were found. It can be concluded that the further down you go, the more production you find on spring. This is because the position of the spring experiences fluid deposits in the form of mud. The results of macrographic examination show that the spring fracture has two fracture surface patterns. Spring B experienced a brittle fracture where the fracture shape was flatter and did not show residual fracture, as seen in Figure 4. Meanwhile springs A, C and D experienced ductile fracture as seen in Figure 3 - Figure 6 which shows residual fracture in the form of a 45° angle. These two fracture patterns have a fast crack propagation path with no fatigue fracture characteristics.

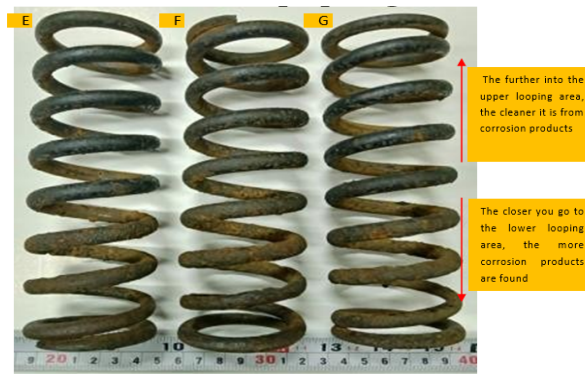
Figure 2. Visual material identification carried out on springs that are not broken

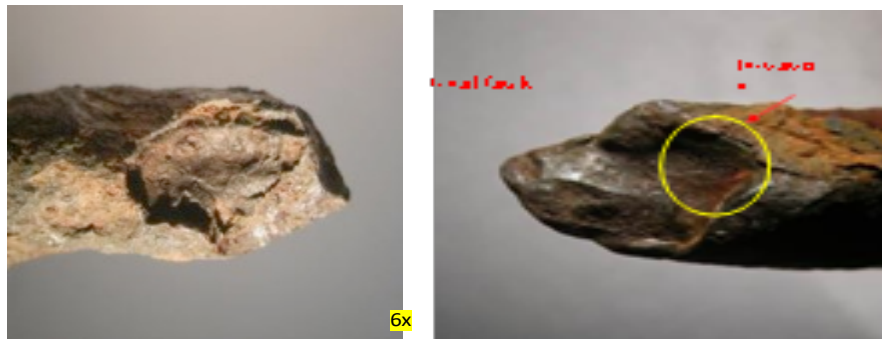
Figure 3. Fracture surface of spring sample A which experienced ductile fracture

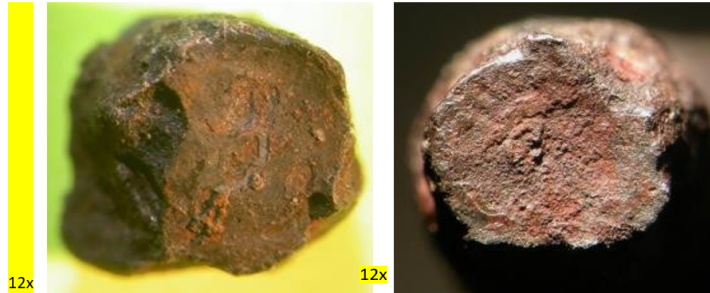
Figure 4. Fracture surface of broken spring sample B which experienced a Brittle fracture

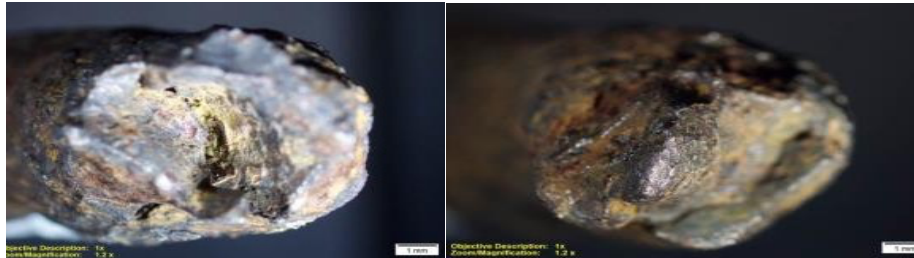
Figure 5. Fracture surface of broken spring sample C which experienced ductile fracture

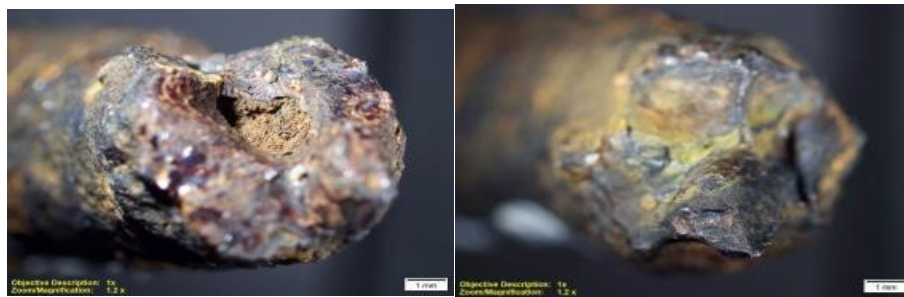
Figure 6. Fracture surface of a broken spring sample D which experienced ductile fracture.

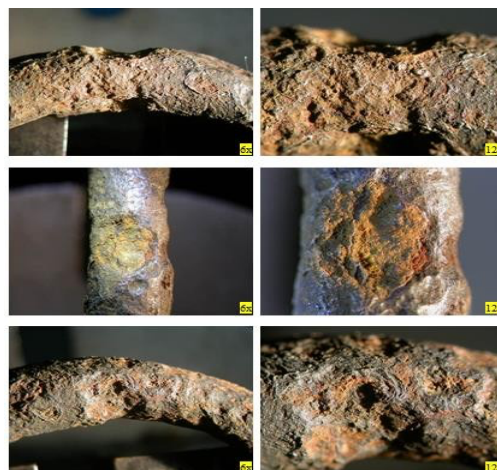
Other damage found that can be seen visually is in the form of holes on the surface (pitting corrosion), both on broken and unbroken springs. There is thinning (reduction in diameter) on the spring surface due to corrosion attacks spread throughout the spring surface and local corrosion at points where there are deposits.

Figure 7. Thinning occurred and several forms of defects were found on the spring surface

The closer to the location of the most critical fracture or thinning, the more corrosion products are found. And conversely, the further away from the location, the fewer corrosion products are found. So it can be concluded that the most critical location of fracture or thinning is the part of the spring that is submerged by fluid entering the spring actuator chamber.

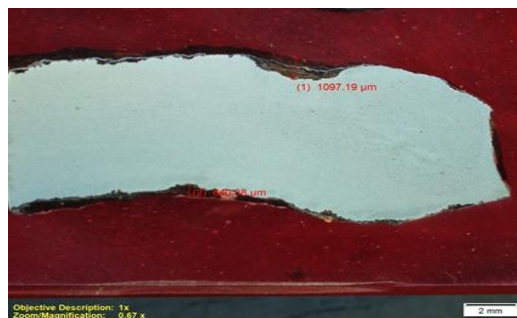
Figure 10. Macro photo of spring etching A fracture surface with a longitudinal cut

At location 1 of the longitudinal cut fracture surface, the defect hole on the spring surface has an irregular shape with a depth of 1097.19 μ m with an image magnification of 6x.

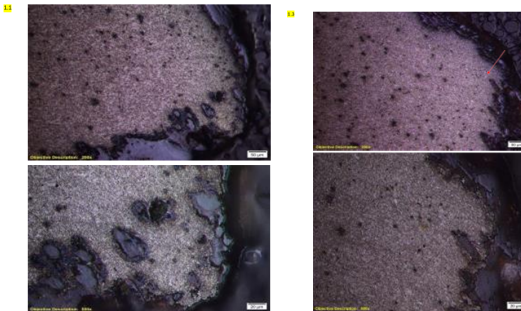
In the non-etching metallographic examination at locations 1.1 and 1.3, corrosion products were found in the spring surface area. There are non-metallic inclusions in the form of sulfides and micro voids.

Figure 12. Metallographic examination of etching locations 1.1 and 1.3 with 200x and 500x magnification

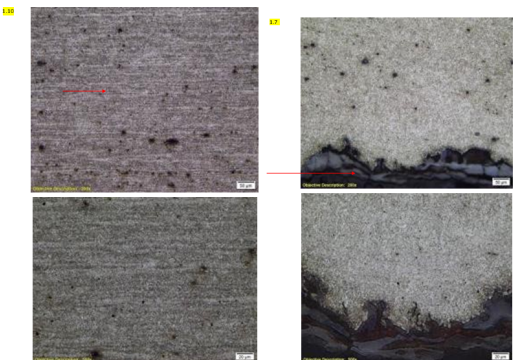
Figure 13. Metallographic examination of etching locations 1.10 and 1.7 with 200x and 500x magnification

From the results of metallographic observations on sample A at location 1, the longitudinal section cuts the microstructure in the form of tempered martensite. Corrosion products were also found in the spring surface area. There are micro voids and inclusions in the form of sulfides. The etching used for this material is 2% nital and the magnification used is with a 200x and 500x magnification lens. At location 2 with an intact surface cross section, the defect hole is semi-circular in shape with the largest depth ± 0.193 mm.

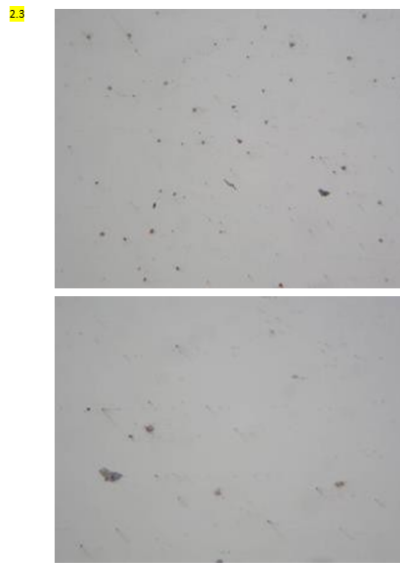
Figure 16 Metallographic examination using non-etching location 2.3

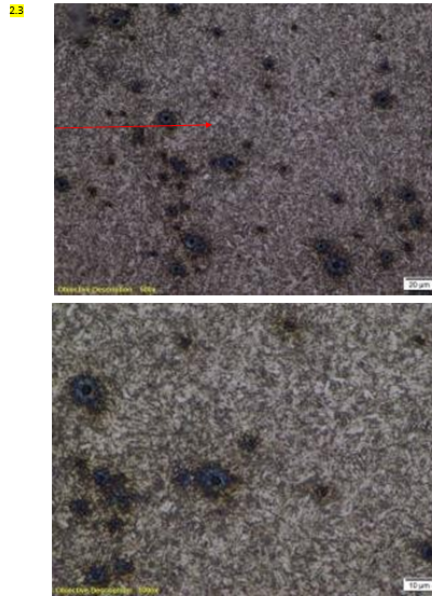
Figure 17 Metallographic examination of location etching 2.3 with 500x and 1000x magnification

From the results of metallographic observations on sample A, location 2 of the transverse direction of the surface is intact, the microstructure is tempered martensite. Corrosion products were also found in the spring surface area. There are micro voids and inclusions in the form of sulfides. No surface hardening was found in the edge area of the spring surface. The etching used for this material is 2% nital and for location 2.3 using 500x and 1000x magnification.

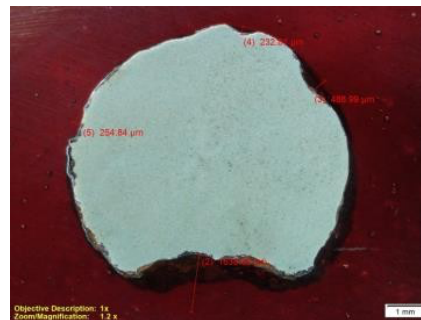
Figure 18 Macro Photo of Corroded Spring A Etching in Cross Section Location 3

At location 3, with a cross section of the corroded surface, the defect hole is semi-circular in shape with the greatest depth measuring ± 1.6 mm.

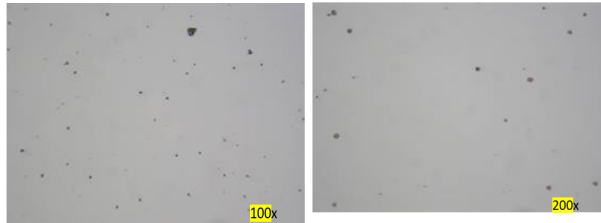
Figure 20 Non-Etching Metallographic Examination Location 3.3

During non-etching metallographic examination at location 3.3, corrosion products were found in the spring surface area. There are non-metallic inclusions in the form of sulfides and micro voids.

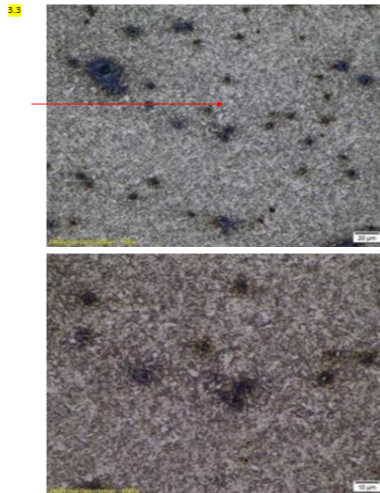
Figure 21 Metallographic examination of location etching 3.3 with 500x and 1000x magnification

From the results of metallographic observations on sample A, location 3 cross-sectional sections of the surface were corroded by a microstructure in the form of tempered martensite. Corrosion products were also found in the spring surface area. There are micro voids and inclusions in the form of sulfides. No surface hardening was found in the edge area of the spring surface. The etching used for this material is 2% nital and for location 3.3 using 500x and 1000x magnification.

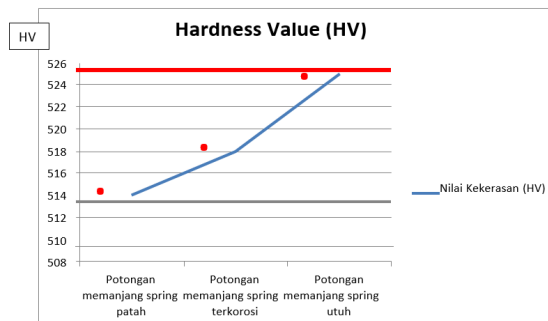
Figure 25 Graph of hardness value (HV) results

Overall, the spring hardness value is above the maximum hardness limit for SUP 12 material. In JIS G 4801 grade SUP 12 material, the maximum hardness limit is 450 HV. This occurs due to the heat treatment process in spring manufacturing.

From the graph of the results of the hardness values above, from intact spring pieces to broken springs, there is a decrease in the hardness value, this is caused by a corrosion attack on the spring.

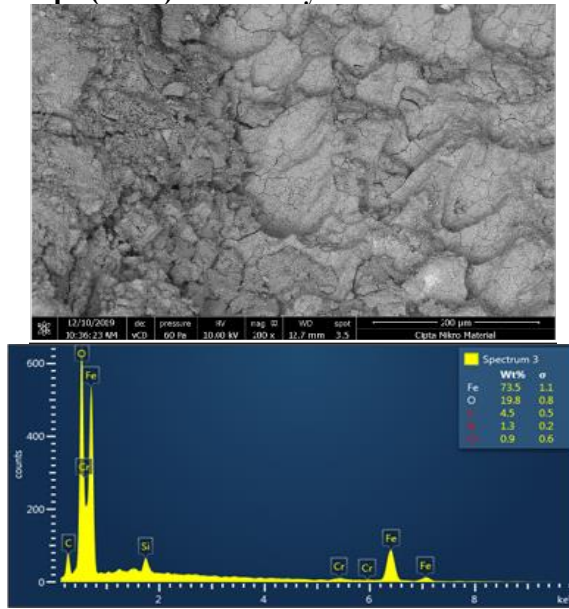
Table 6 SEM-EDAX Results of Fracture Surface *SpringA*

SEM test results of spring samples show the presence of non-metallic inclusions with an elongated morphology and micro-sized voids. Meanwhile, the EDX test results showed that there was a sulfur content of 4.71 wt% in non-metallic inclusions and Fe and O elements in defect holes which were corrosion products.
