Analysis of Spring Damage in the Chamber Actuator

Abstract: Spring, which has the function to help the valve operate so that it can be fully closed and fully open, has a very vital role in the continuous operation of the chemical industry. When a problem occurs, muddy fluid is found in the spring actuator chamber which causes the valve not to operate and not be in full close condition. The purpose of this study is to find the causes of the Spring Actuator failure in the chemical industry. This research was specifically directed at a broken Spring Actuator to determine the cause of the failure/damage. The tests carried out were: fractography, metallography (microstructure), chemical composition analysis, hardness test, and scanning electron microscope (SEM) energy dispersive x-ray (EDX) analysis. The results of the macrographic examination showed that the spring fracture had 2 fracture surface patterns. Spring B has a brittle fracture where the shape of the fracture is more even and does not show residual fracture. While springs A, C, and D experienced ductile fracture. The results of metallography found corrosion products in the surface area of the spring. There are non-metallic i

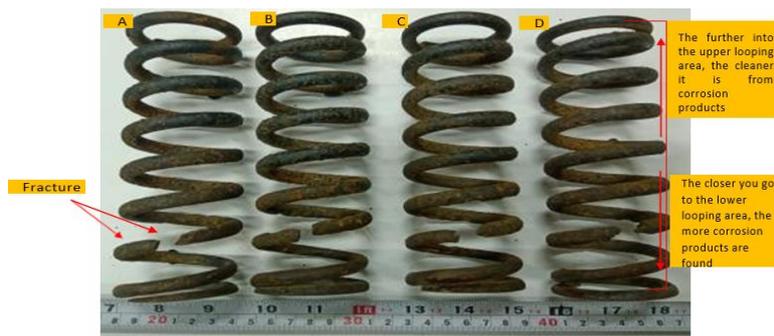
Figure 1. Visual material identification carried out on broken springs

From the results of visual observations of broken and unbroken springs, it can be seen that at the bottom of the spring the most corrosion production was found. Meanwhile, at the top, only a few corrosion products were found. It can be concluded that the further down you go, the more production you find on spring. This is because the position of the spring experiences fluid deposits in the form of mud. The results of macrographic examination show that the spring fracture has two fracture surface patterns. Spring B experienced a brittle fracture where the fracture shape was flatter and did not show residual fracture, as seen in Figure 4. Meanwhile springs A, C and D experienced ductile fracture as seen in Figure 3 - Figure 6 which shows residual fracture in the form of a 45° angle. These two fracture patterns have a fast crack propagation path with no fatigue fracture characteristics.

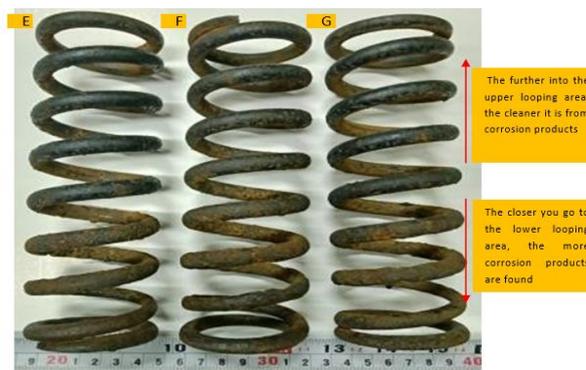
Figure 2. Visual material identification carried out on springs that are not broken

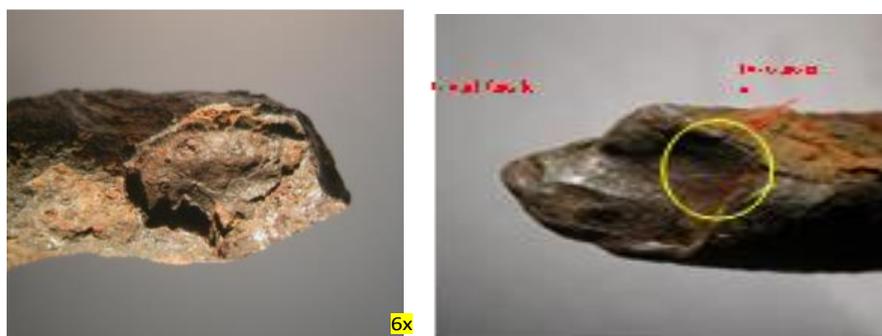
Figure 3. Fracture surface of spring sample A which experienced ductile fracture

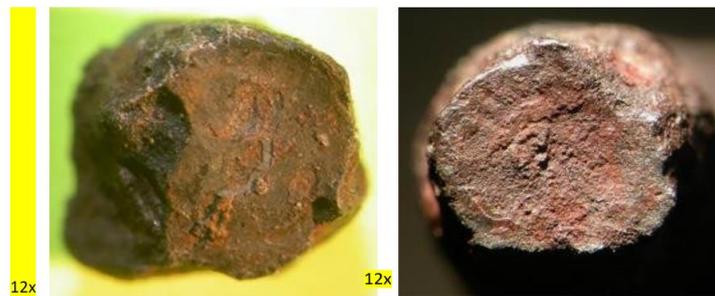
Figure 4. Fracture surface of broken spring sample B which experienced a Brittel fracture

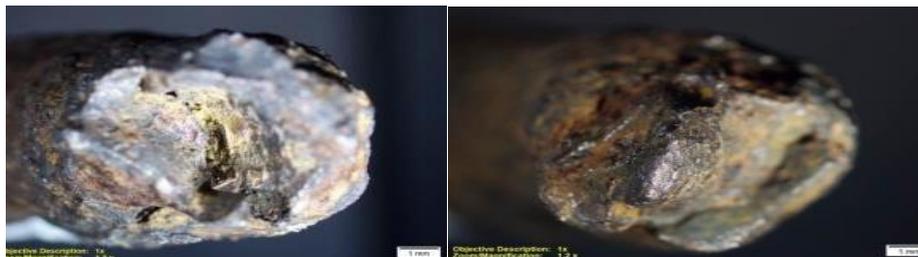
Figure 5. Fracture surface of broken spring sample C which experienced ductile fracture

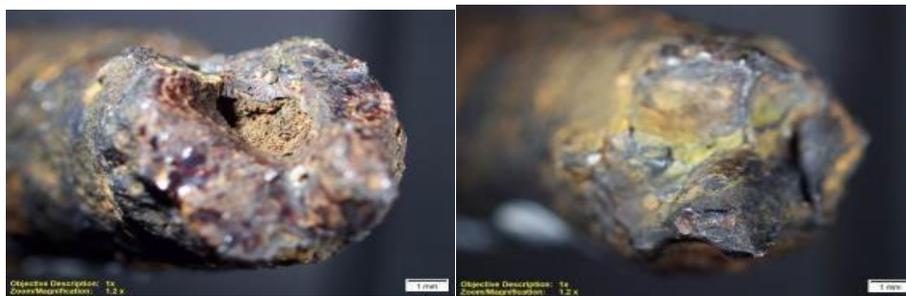
Figure 6. Fracture surface of a broken spring sample D which experienced ductile fracture.

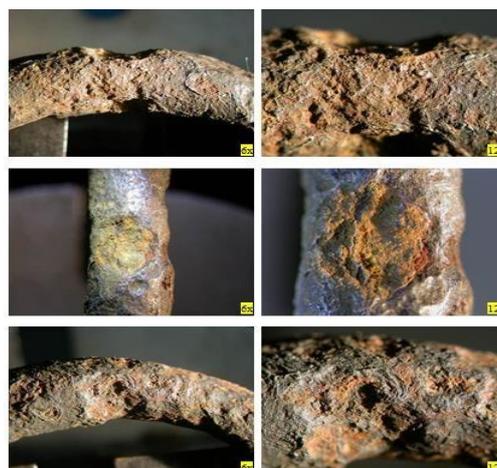
Other damage found that can be seen visually is in the form of holes on the surface (pitting corrosion), both on broken and unbroken springs. There is thinning (reduction in diameter) on the spring surface due to corrosion attacks spread throughout the spring surface and local corrosion at points where there are deposits.

Figure 7. Thinning occurred and several forms of defects were found on the spring surface

The closer to the location of the most critical fracture or thinning, the more corrosion products are found. And conversely, the further away from the location, the fewer corrosion products are found. So it can be concluded that the most critical location of fracture or thinning is the part of the spring that is submerged by fluid entering the spring actuator

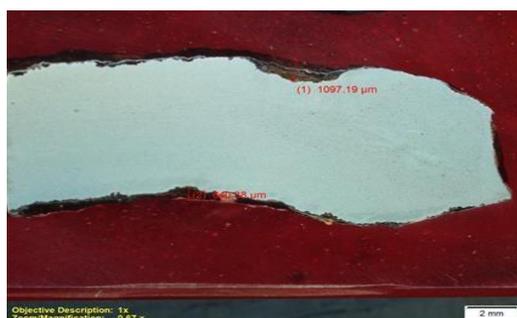
At location 1 of the longitudinal cut fracture surface, the defect hole on the spring surface has an irregular shape with a depth of 1097.19 μ m with an image magnification of 6x.

Figure 10. Macro photo of spring etching A fracture surface with a longitudinal cut

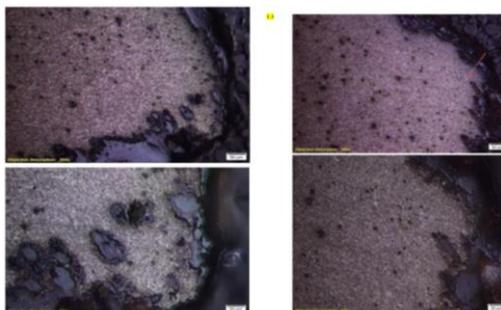
In the non-etching metallographic examination at locations 1.1 and 1.3, corrosion products were found in the spring surface area. There are non-metallic inclusions in the form of sulfides and micro voids.

Figure 12. Metallographic examination of etching locations 1.1 and 1.3 with 200x and 500x magnification

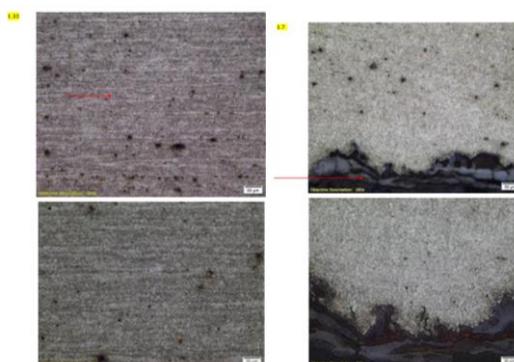
Figure 13. Metallographic examination of etching locations 1.10 and 1.7 with 200x and 500x magnification

From the results of metallographic observations on sample A at location 1, the longitudinal section cuts the microstructure in the form of tempered martensite. Corrosion products were also found in the spring surface area. There are micro voids and inclusions in the form of sulfides. The etching used for this material is 2% nital and the magnification used is with a 200x and 500x magnification lens. At location 2 with an intact surface cross section, the defect hole is semi-circular in shape with the largest depth ± 0.193 mm.

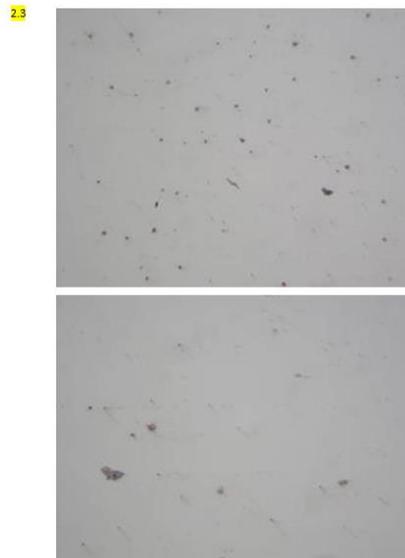
Figure 16 Metallographic examination using non-etching location 2.3

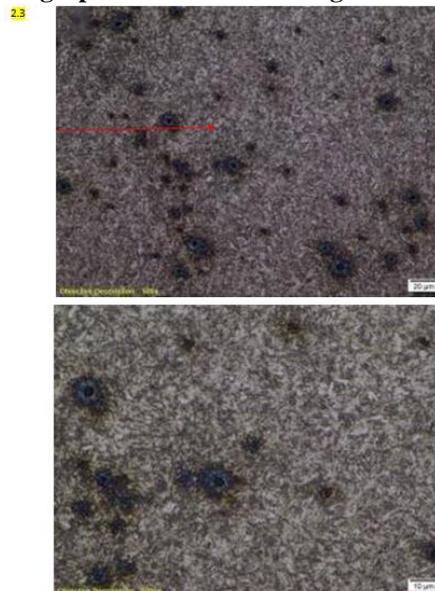
Figure 17 Metallographic examination of location etching 2.3 with 500x and 1000x magnification

From the results of metallographic observations on sample A, location 2 of the transverse direction of the surface is intact, the microstructure is tempered martensite. Corrosion products were also found in the spring surface area. There are micro voids and inclusions in the form of sulfides. No surface hardening was found in the edge area of the spring surface. The etching used for this material is 2% nital and for location 2.3 using 500x and 1000x magnification.

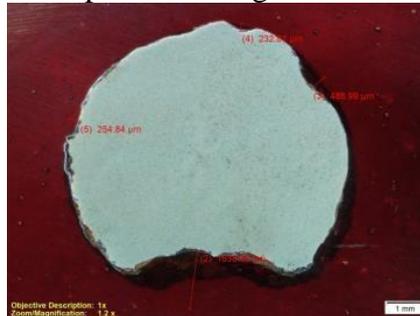
At location 3, with a cross section of the corroded surface, the defect hole is semi-circular in shape with the greatest depth measuring ± 1.6 mm.

Figure 18 Macro Photo of Corroded Spring A Etching in Cross Section Location 3

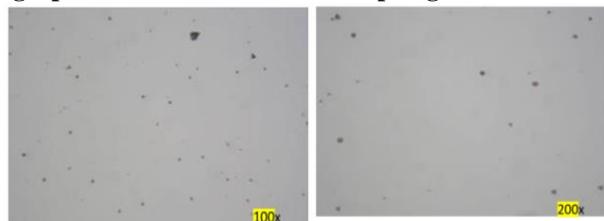
Figure 20 Non-Etching Metallographic Examination Location 3.3

During non-etching metallographic examination at location 3.3, corrosion products were found in the spring surface area. There are non-metallic inclusions in the form of sulfides and micro voids.

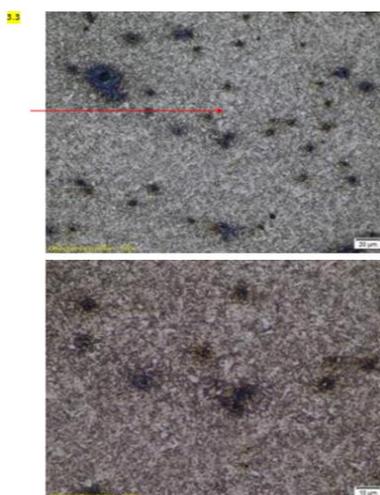
Figure 21 Metallographic examination of location etching 3.3 with 500x and 1000x magnification

From the results of metallographic observations on sample A, location 3 cross-sectional sections of the surface were corroded by a microstructure in the form of tempered martensite. Corrosion products were also found in the spring surface area. There are micro voids and inclusions in the form of sulfides. No surface hardening was found in the edge area of the spring surface. The etching used for this material is 2% nital and for location 3.3 using 500x and 1000x magnification.

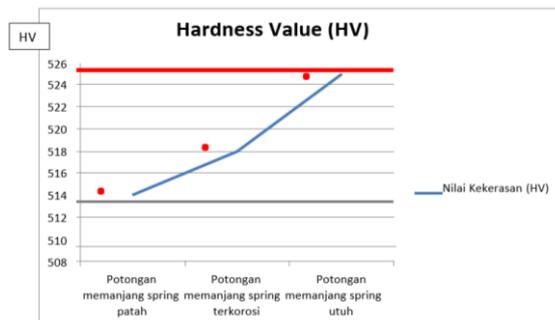
Overall, the spring hardness value is above the maximum hardness limit for SUP 12 material. In JIS G 4801 grade SUP 12 material, the maximum hardness limit is 450 HV. This occurs due to the heat treatment process in spring manufacturing.

Figure 25 Graph of hardness value (HV) results

From the graph of the results of the hardness values above, from intact spring pieces to broken springs, there is a decrease in the hardness value, this is caused by a corrosion attack on the spring.

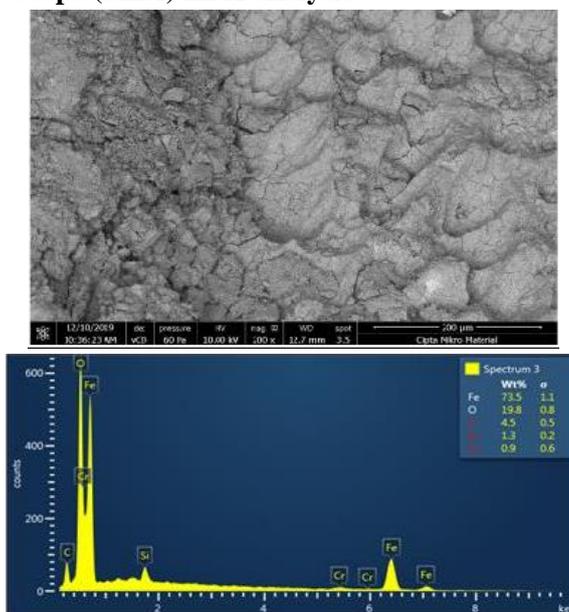
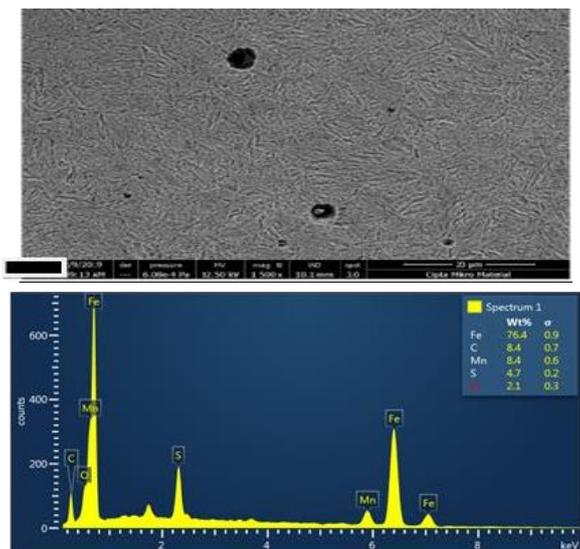
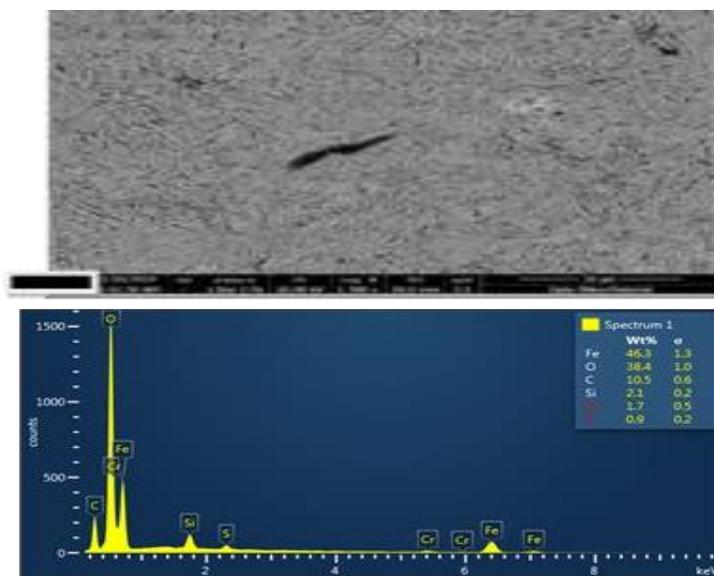
SEM test results of spring samples show the presence of non-metallic inclusions with an elongated morphology and micro-sized voids. Meanwhile, the EDX test results showed that there was a sulfur content of 4.71 wt% in non-metallic inclusions and Fe and O elements in defect holes which were corrosion products.
