## Efforts to Optimize Injector Performance for The Combustion Process in The Diesel Generator on The Mt. Gas Patra 3

Based on the description above, the authors are interested in raising this issue in the preparation of a thesis with the title: Efforts to Optimize Injector Performance on the Combustion Process in Diesel Generators on LPG/C Gas Patra 3 Ships.

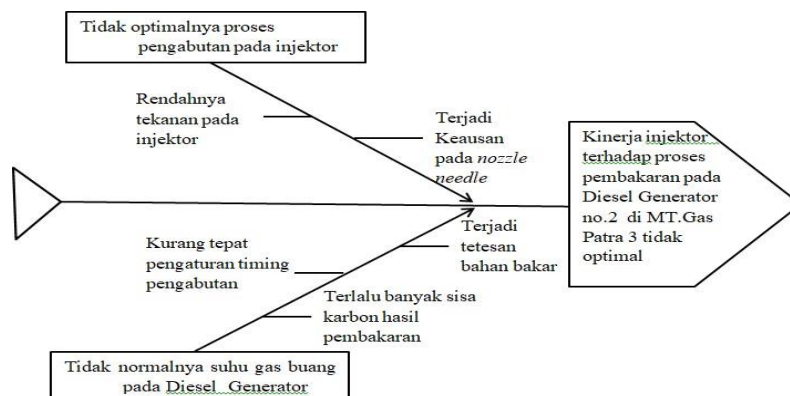
Methods/techniques of analysis using a qualitative approach with qualitative descriptive analysis techniques. The subject of this research is Yanmar S165L-DN Diesel Generator Injector. The data analysis method used by the author in addressing the problem is the fishbone method to identify problem factors. The fishbone diagram method is a method for analyzing the causes of a problem or condition. Often this diagram is also called a cause-and-effect diagram or cause effect diagram.
