Analysis of Spring Damage in the Chamber Actuator

Raven Rullyapatra Nasution¹, Rudi Saputra²

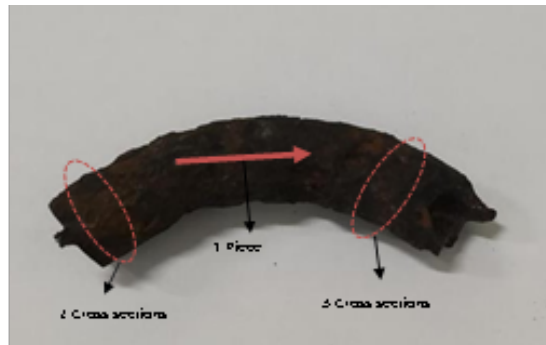
Figure 8. Location of Cutting Direction for Metallographic Sample Sample A

Metallographic examination was carried out at 3 locations where spring A was broken, namely: the fracture surface in longitudinal section (location 1), the intact spring in cross section (location 2) and the corroded spring in cross section (location 3).

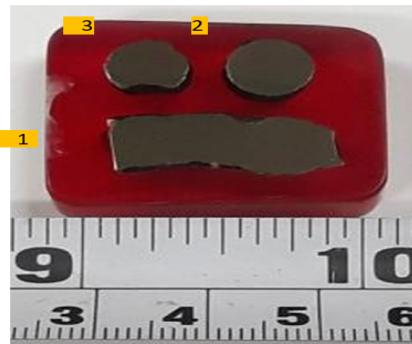
Figure 9. Location of Etched and Non-Etched Metallographic Examination of Spring Sample A

At location 1 of the longitudinal cut fracture surface, the defect hole on the spring surface has an irregular shape with a depth of 1097.19 μ m with an image magnification of 6x.

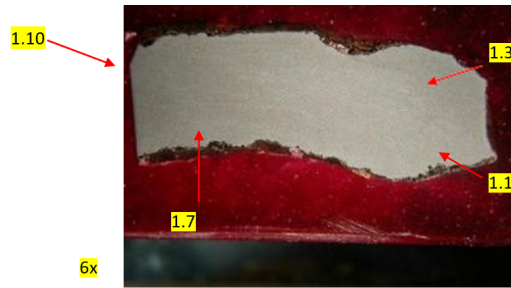
Figure 11 Photomicrographic Location of Spring A, Fracture Surface with Longitudinal Sections.

In the non-etching metallographic examination at locations 1.1 and 1.3, corrosion products were found in the spring surface area. There are non-metallic inclusions in the form of sulfides and micro voids.

From the results of metallographic observations on sample A at location 1, the longitudinal section cuts the microstructure in the form of tempered martensite. Corrosion products were also found in the spring surface area. There are micro voids and inclusions in the form of sulfides. The etching used for this material is 2% nital and the magnification used is with a 200x and 500x magnification lens. At location 2 with an intact surface cross section, the defect hole is semi-circular in shape with the largest depth ± 0.193 mm.

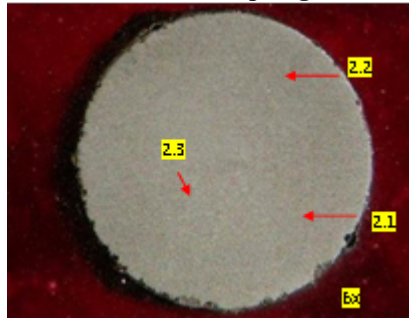
Figure 15 Whole Spring A Metallographic Location with Cross Section at Location 2

From the results of metallographic observations on sample A, location 2 of the transverse direction of the surface is intact, the microstructure is tempered martensite. Corrosion products were also found in the spring surface area. There are micro voids and inclusions in the form of sulfides. No surface hardening was found in the edge area of the spring surface. The etching used for this material is 2% nital and for location 2.3 using 500x and 1000x magnification.

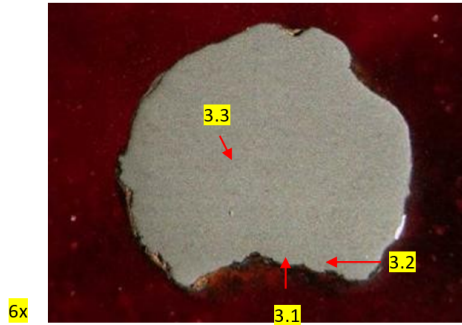
Figure 19 Metallographic Location of Corroded Spring A with Cross Section Location 3

At location 3, with a cross section of the corroded surface, the defect hole is semi-circular in shape with the greatest depth measuring ± 1.6 mm.

During non-etching metallographic examination at location 3.3, corrosion products were found in the spring surface area. There are non-metallic inclusions in the form of sulfides and micro voids.

From the results of metallographic observations on sample A, location 3 cross-sectional sections of the surface were corroded by a microstructure in the form of tempered martensite. Corrosion products were also found in the spring surface area. There are micro voids and inclusions in the form of sulfides. No surface hardening was found in the edge area of the spring surface. The etching used for this material is 2% nital and for location 3.3 using 500x and 1000x magnification.

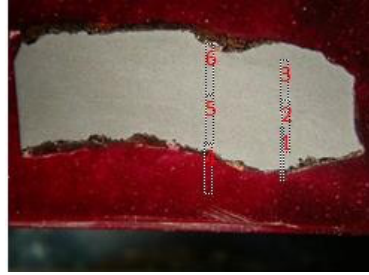
Figure 22 Location of Longitudinal Section Hardness Test for Broken Spring

The figure above shows the scheme and data collection points for hardness testing on longitudinal cut spring material that has failed. The hardness test results show that the longitudinal cut broken spring has a hardness value of 514 HV.

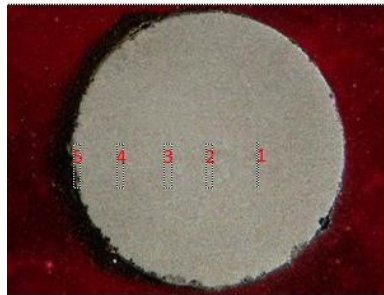
Figure 23 Location of Cross-Section Hardness Test of Whole Spring

The image above shows the scheme and data collection points for hardness testing on intact cross-sectional spring material (sample 2) which failed. From the table above it shows that a broken spring in intact cross section has a hardness value of 525 HV.

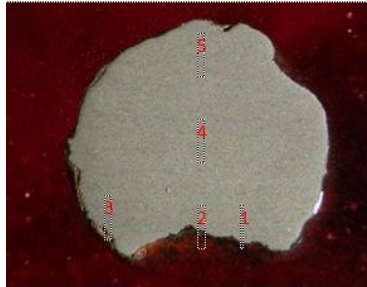
Figure 24 Location of Corroded Spring Cross Section Hardness Test
Table 5 Cross section hardness test results of corroded spring

The image above shows the scheme and data collection points for hardness testing on intact cross-sectional spring material (sample 2) which failed. From the table above it shows that a broken spring in intact cross section has a hardness value of 525 HV. The image above shows the scheme and data collection points for hardness testing The picture above shows the scheme and data collection points for hardness testing on a corroded cross-sectional material spring (sample 3) which failed. The hardness test results show that the corroded cross-sectional broken spring has a hardness value of 518.4 HV.
