Analysis of Spring Damage in the Chamber Actuator

Abstract: Spring, which has the function to help the valve operate so that it can be fully closed and fully open, has a very vital role in the continuous operation of the chemical industry. When a problem occurs, muddy fluid is found in the spring actuator chamber which causes the valve not to operate and not be in full close condition. The purpose of this study is to find the causes of the Spring Actuator failure in the chemical industry. This research was specifically directed at a broken Spring Actuator to determine the cause of the failure/damage. The tests carried out were: fractography, metallography (microstructure), chemical composition analysis, hardness test, and scanning electron microscope (SEM) energy dispersive x-ray (EDX) analysis. The results of the macrographic examination showed that the spring fracture had 2 fracture surface patterns. Spring B has a brittle fracture where the shape of the fracture is more even and does not show residual fracture. While springs A, C, and D experienced ductile fracture. The results of metallography found corrosion products in the surface area of the spring. There are non-metallic i

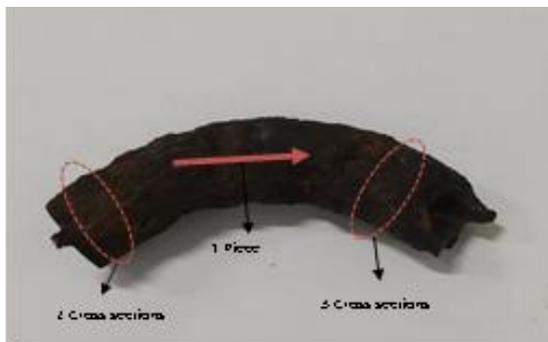
Figure 8. Location of Cutting Direction for Metallographic Sample Sample A

Metallographic examination was carried out at 3 locations where spring A was broken, namely: the fracture surface in longitudinal section (location 1), the intact spring in cross section (location 2) and the corroded spring in cross section (location 3).

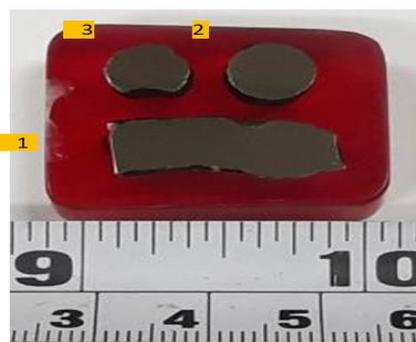
Figure 9. Location of Etched and Non-Etched Metallographic Examination of Spring Sample A

At location 1 of the longitudinal cut fracture surface, the defect hole on the spring surface has an irregular shape with a depth of 1097.19 μ m with an image magnification of 6x.

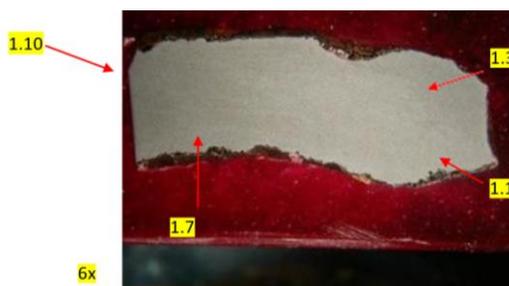
Figure 11 Photometallographic Location of Spring A, Fracture Surface with Longitudinal Sections.

In the non-etching metallographic examination at locations 1.1 and 1.3, corrosion products were found in the spring surface area. There are non-metallic inclusions in the form of sulfides and micro voids.

From the results of metallographic observations on sample A at location 1, the longitudinal section cuts the microstructure in the form of tempered martensite. Corrosion products were also found in the spring surface area. There are micro voids and inclusions in the form of sulfides. The etching used for this material is 2% nital and the magnification used is with a 200x and 500x magnification lens. At location 2 with an intact surface cross section, the defect hole is semi-circular in shape with the largest depth ± 0.193 mm.

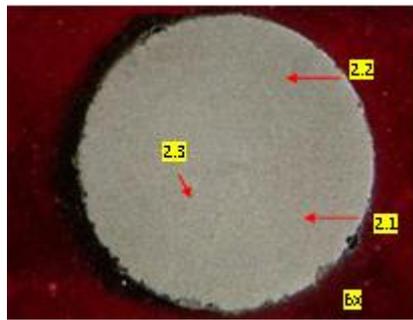
Figure 15 Whole Spring A Metallographic Location with Cross Section at Location 2

From the results of metallographic observations on sample A, location 2 of the transverse direction of the surface is intact, the microstructure is tempered martensite. Corrosion products were also found in the spring surface area. There are micro voids and inclusions in the form of sulfides. No surface hardening was found in the edge area of the spring surface. The etching used for this material is 2% nital and for location 2.3 using 500x and 1000x magnification.

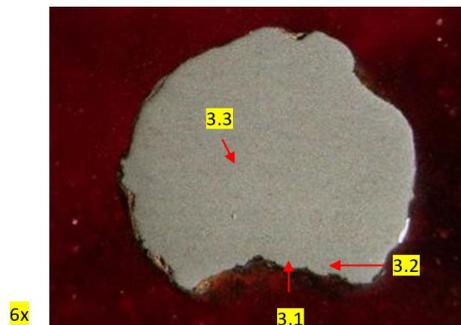
Figure 19 Metallographic Location of Corroded Spring A with Cross Section Location 3

At location 3, with a cross section of the corroded surface, the defect hole is semi-circular in shape with the greatest depth measuring ± 1.6 mm.

During non-etching metallographic examination at location 3.3, corrosion products were found in the spring surface area. There are non-metallic inclusions in the form of sulfides and micro voids.

From the results of metallographic observations on sample A, location 3 cross-sectional sections of the surface were corroded by a microstructure in the form of tempered martensite. Corrosion products were also found in the spring surface area. There are micro voids and inclusions in the form of sulfides. No surface hardening was found in the edge area of the spring surface. The etching used for this material is 2% nital and for location 3.3 using 500x and 1000x magnification.

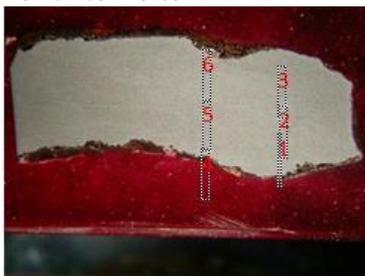
Figure 22 Location of Longitudinal Section Hardness Test for Broken Spring

No	Hardness Value (HV)
1	515
2	532
3	507
4	500
5	523
6	507
Average	514

The figure above shows the scheme and data collection points for hardness testing on longitudinal cut spring material th at has failed. The hardness test results show that the longitudinal cut broken spring has a hardness value of 514 HV.

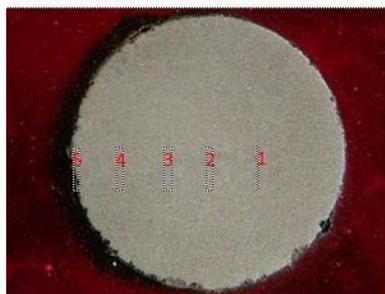
Figure 23 Location of Cross-Section Hardness Test of Whole Spring

No	Hardness Value (HV)
1	532
2	532
3	515
4	523
5	523
Average	525

The image above shows the scheme and data collection points for hardness testing on intact cross-sectional spring material (sample 2) which failed. From the table above it shows that a broken spring in intact cross section has a hardness value of 525 HV.

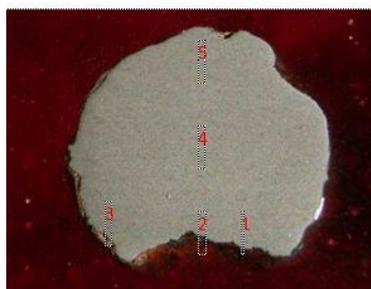
Figure 24 Location of Corroded Spring Cross Section Hardness Test

From the graph of the results of the hardness values above, from intact spring pieces to broken springs, there is a decrease in the hardness value, this is caused by a corrosion attack on the spring.
